Window Reflections ML8300

Richard Crisp rdcrisp@earthlink.net www.narrowbandimaging.com

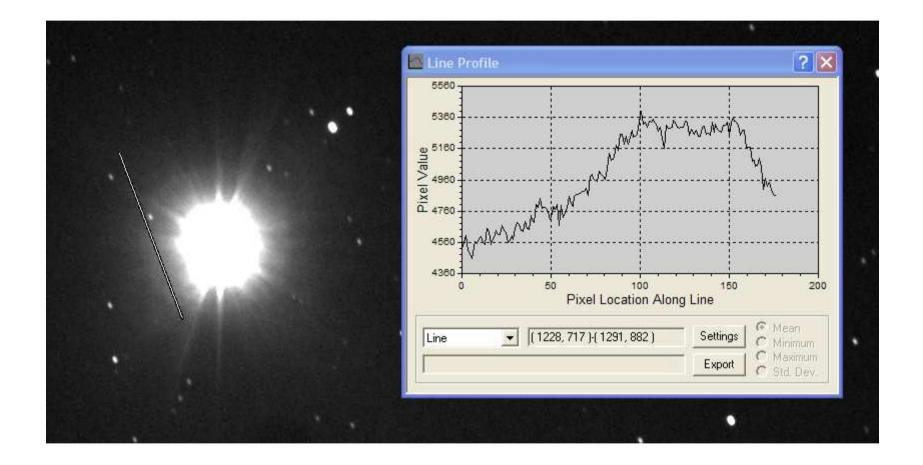
Line Profile: Stock Window

- Stock window exhibits circular haloes when used in FSQ106 system with no filter
- Haloes diminished using "K" and "J" windows
- "K" window gives best results of the four. Spectral transmission characteristics not measured
- Images taken with no window show rectangular halo
- Examination of camera interior reveal highly reflective rectangular sensor surface surrounded by reflective surfaces from the PCB, and semiconductor packaging

- Check spectral transmission characteristics of each window. If "K" is acceptable, use type "K" for ML8300 windows
- Make anti-reflective bezel to surround image sensor: make coplanar with image sensor coverslip

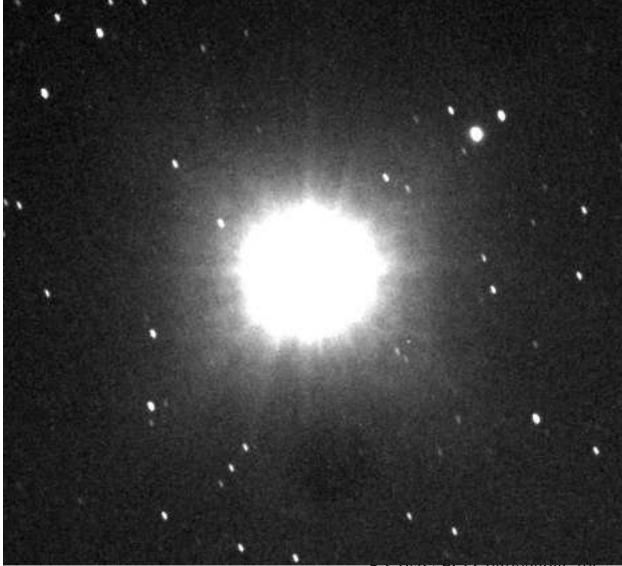
Rectangular Halo (No window)

- Observed in all images
- Most prominent in images with circular halo diminished
- Observable in nowindow case

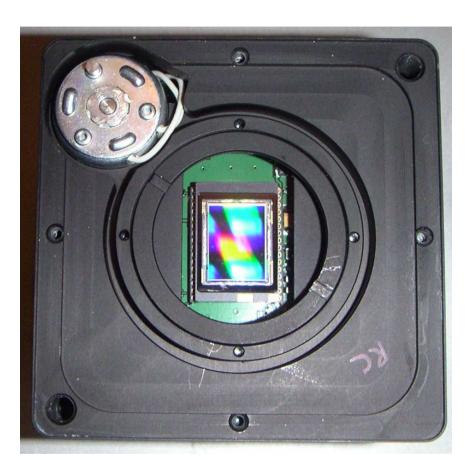
Camera Interior (shutter removed)

Image taken with flashsensorNote reflection from sensorpinssurfaceR Crisp / FLI Confidential: for

- Rectangular reflective shapes observed:
 - Rectangular sensor is highly reflective: note the pattern
 - Shiny ring surrounding edge of die
- PCB is highly reflective but not so much as the sensor
- Exposed gold surfaces on sensor package and socket pins

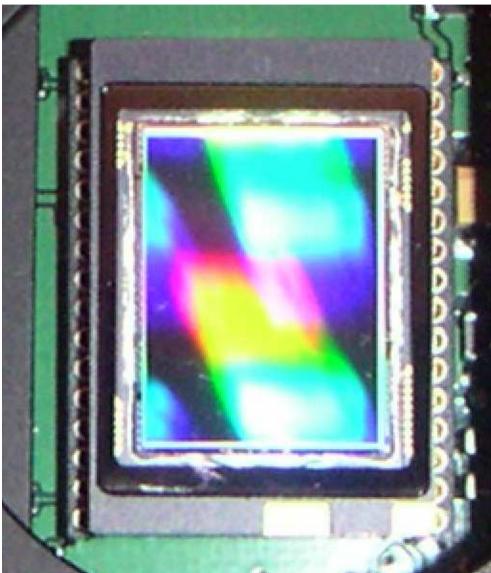
Sensor Area

- Many reflective surfaces
- Metal ring around outside edge of die
- Bonding fingers on package
- Gold surfaces on sensor package
- Gold socket tips
