Window Reflections ML8300

Richard Crisp rdcrisp@earthlink.net www.narrowbandimaging.com

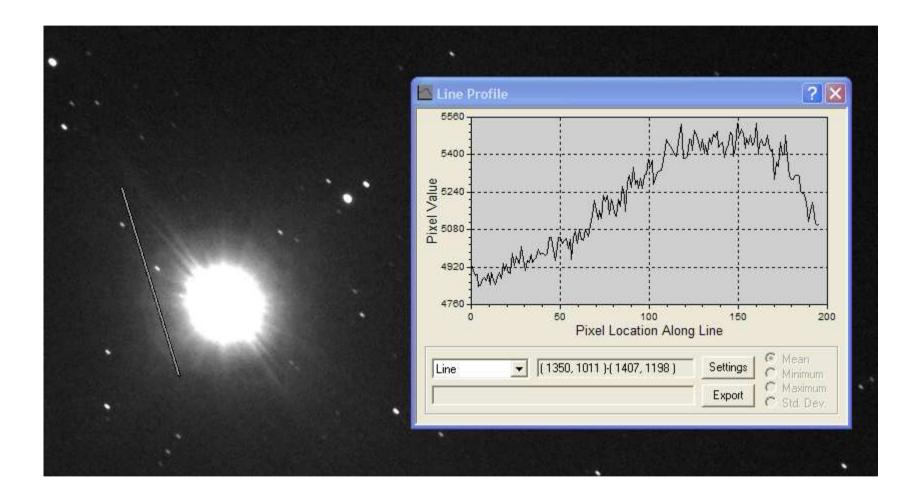
Line Profile: "E" Window

- Stock window exhibits circular haloes when used in FSQ106 system with no filter
- Haloes diminished using "K" and "J" windows
- "K" window gives best results of the four. Spectral transmission characteristics not measured
- Images taken with no window show rectangular halo
- Examination of camera interior reveal highly reflective rectangular sensor surface surrounded by reflective surfaces from the PCB, and semiconductor packaging

- Check spectral transmission characteristics of each window. If "K" is acceptable, use type "K" for ML8300 windows
- Make anti-reflective bezel to surround image sensor: make coplanar with image sensor coverslip
